# FC563U NEW [11" Single Stage Pressure Plate, w/1-7/8" 29 Spline Hub - New]

Instruction Guide

## Borg Beck Clutch Information

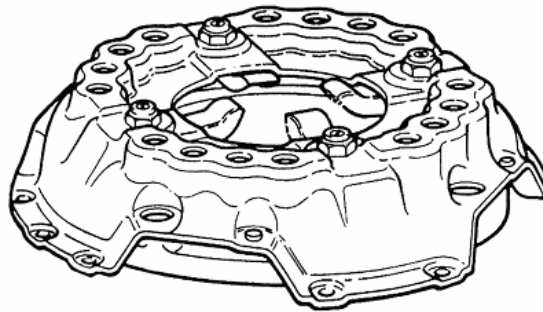
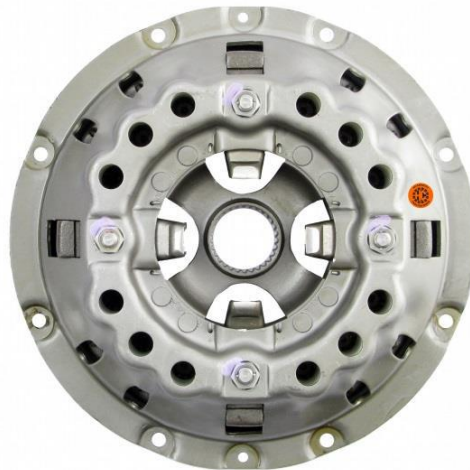
The primary cause of lever strut displacement has been identified as the release lever or release lever plates being pulled away from the flywheel, putting excess pressure on the anti-rattle spring. This results in the strut being left in a "free" position and will cause it to fall out of the correct pivot position. One or more release levers positioned higher than the other would indicate a strut being out of position. If this problem is not corrected, the clutch will not function properly. Please call our Service Department if you identify this issue.
